Review of Modern Nondestructive Testing Techniques for Civil Infrastructure

**Problem Report submitted to the
Benjamin M. Statler College of Engineering and Mineral Resources
at West Virginia University
in partial fulfillment of the requirements
for the degree of**

**Master of Science
in
Civil Engineering**

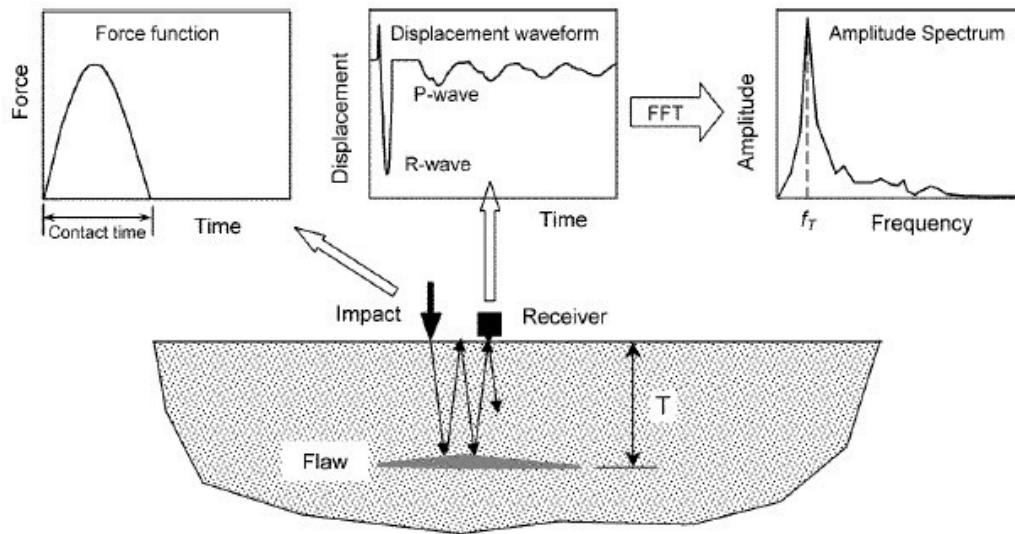
Figure 2.1: Schematic diagram of IE method (Carino 2015).

IE method comprises of three components: an impactor, a transducer, and data acquisition and analysis system. It is based on the impact generated stress waves that propagate through the member and is reflected by any discontinuities, such as internal defects and external surfaces, due to differences in acoustic impedances. An impactor, such as a hammer or steel sphere, generates high-energy stress waves with low frequency (typically between 5 and 40 kHz) that can penetrate deep into the test structural member (Schubert and Kohler 2008). The size of an impactor influences contact duration, the frequency range of the wave and minimum depth of the discontinuity that can be determined (ASTM C1383-15). In the case of slender members, such as piles, hammers are used as impactors with longer contact duration (greater than 1 ms) whereas for members less than 40 in. (1 m) thick, steel spheres with shorter contact duration (20 to 80 μ s) are used (ACI 228.2R-13). The diameter of steel balls is inversely proportional to the maximum frequency of the stress waves (Sansalone and Carino 1986).

The receiving transducer measures the mechanical surface displacement caused by the reflection of stress waves and converts it into a time-domain waveform. The reflection should be dominated by P-wave, which is made possible by the placement of transducers close to the impact point (Sansalone and Carino 1986). The recommended spacing is less than 40 % of the flaw depth (Sansalone and Streett 1997 and ASTM C1383-15). However, if placed too close, Rayleigh waves will dominate affecting the test data. Geophones (velocity transducer) and accelerometers are commonly used for slender members. Accelerometers are accurate for high frequencies whereas

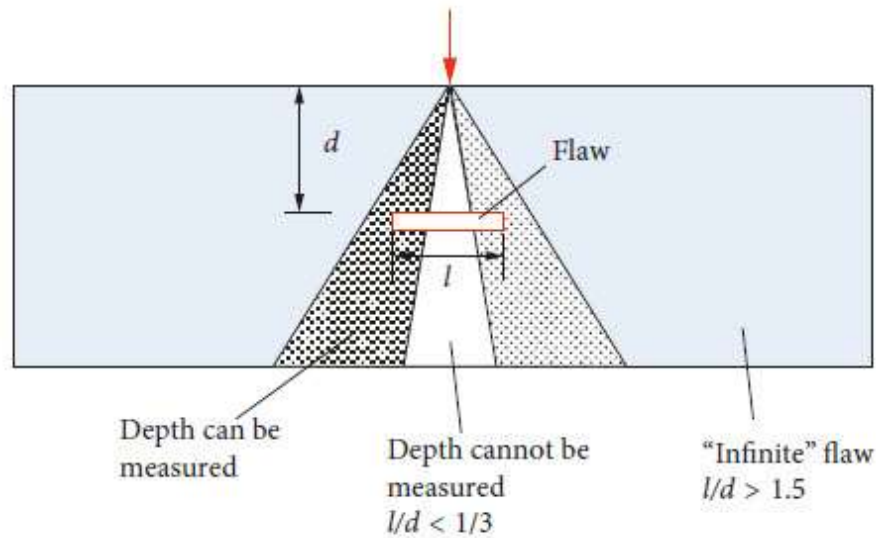
Figure 2.2: Detectable range of horizontal void using IE method (Carino 2001, Liu et al. 2019).

Liu et al. 2019). Additionally, the embedded reinforcement can be detected only if its thickness (t) is greater than half its wavelength ($\lambda/2$) (Schubert and Kohler 2008). This rule can be applied to the detection of any defect.

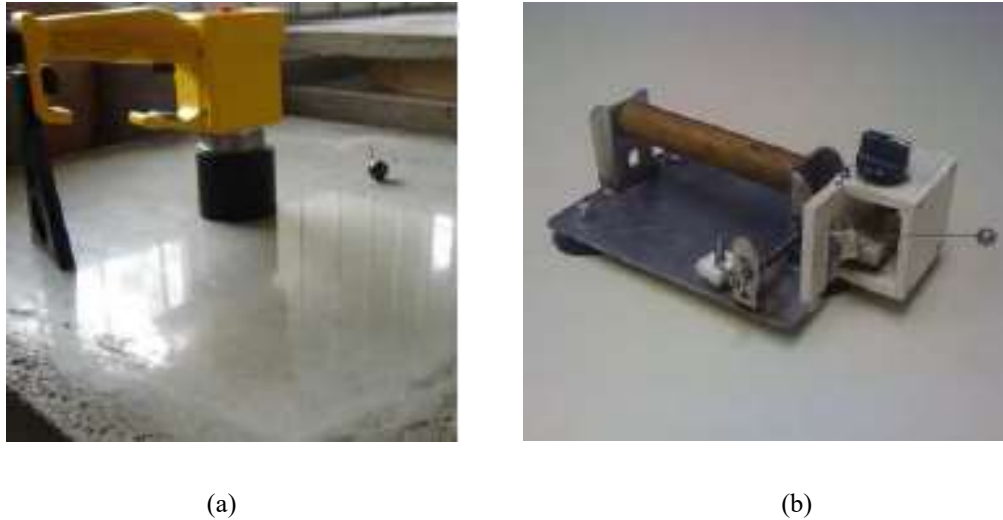
Figure 2.3: (a) Transducer with manual impactor; (b) Mechanical impact device (Grabovski et al. 2011).

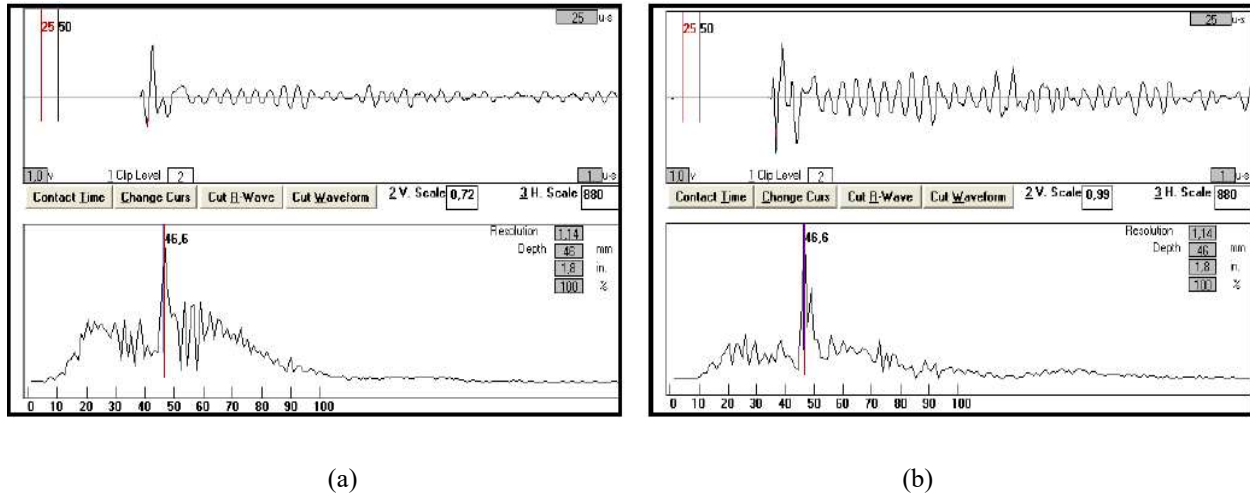
Figure 2.4: Waveforms and frequency spectra for 43 mm dry cured slab with (a) manual; (b) mechanical impact (Grabovski et al. 2011).

concrete plates with dry and wet cure respectively were 1.8% and 0.2% (60 mm), 3.9% and 0% (40 mm), and 3.9% and 1% (30 mm). The frequencies, on average, for the saturated samples were about 1.7% higher than dry samples, compliant with the ultrasonic pulse velocity (higher by 2% in saturated concrete than in dry).

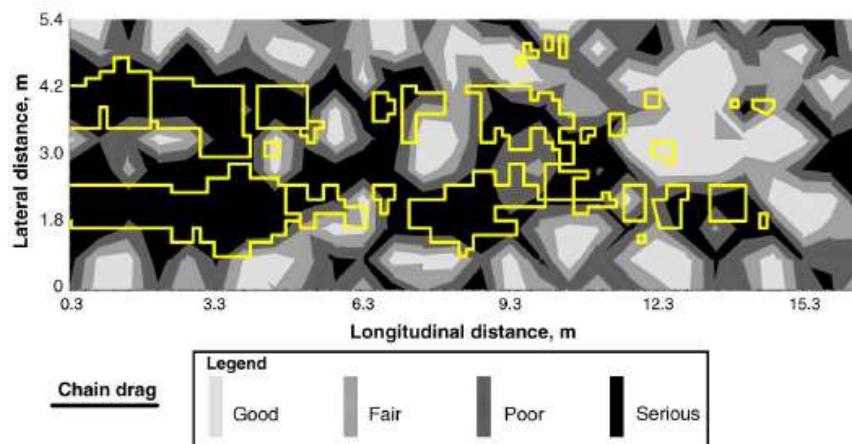
Figure 2.6: Condition map of Van Buren Bridge from PSPA (Gucunski et al. 2012).

Figure 2.6 presents the condition map of the Van Buren Bridge in VA, acquired using PSPA, which clearly illustrated the deteriorated condition of the deck, ranging from good to serious (sound, initial and progressed delamination). Chain drag data, on the other hand, was able to estimate only the poor to the serious condition (progressed) of the deck (represented by area under yellow lines). The Stepper was used for the assessment of the bridge on Route 18 over the Cedar River in Iowa. Figure 2.7 shows the condition map of its deck, where the shaded white parts were the repaired sections after chain drag results. The delaminated and sound conditions shown in the map were found consistent with the observation from coring, as shown in the figure.

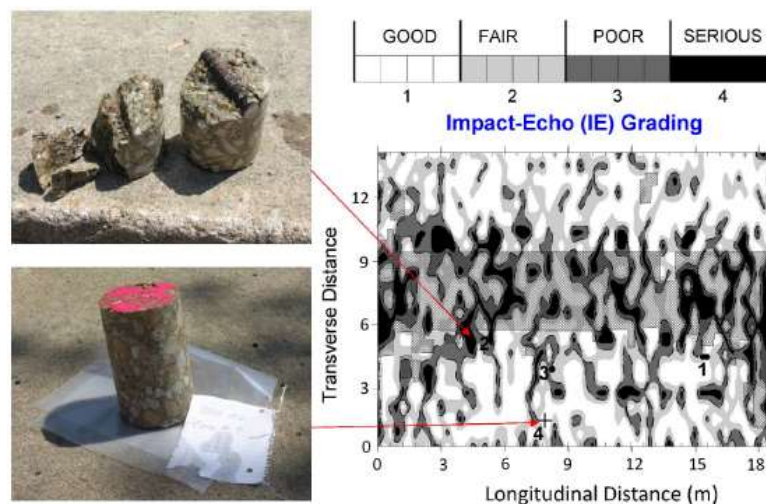
Figure 2.7: Condition map of Route 18, Iowa Bridge with extracted cores (Gucunski et al. 2012).

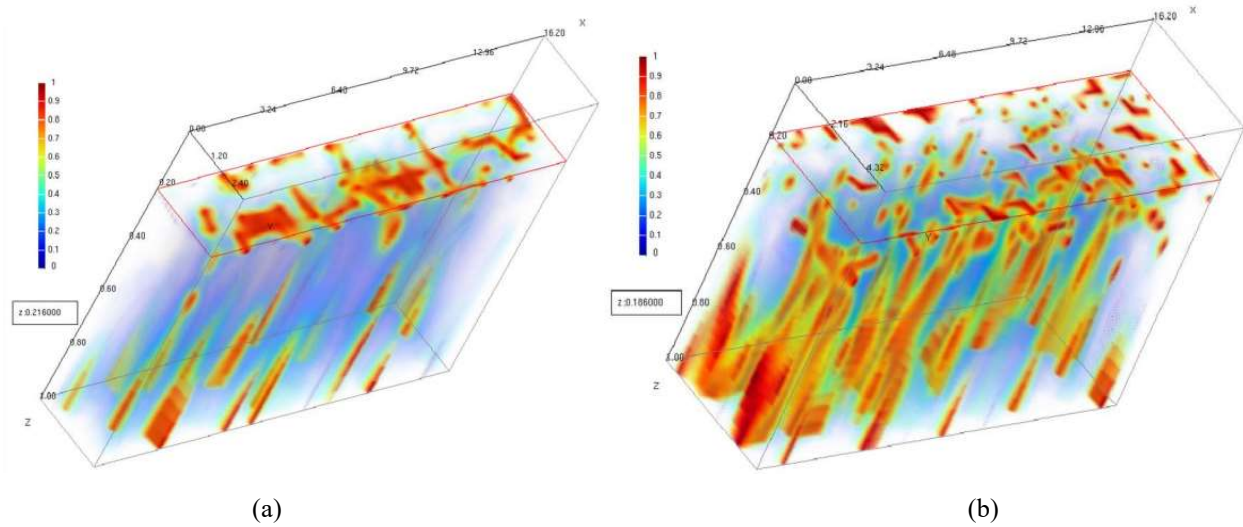
Figure 2.8: 3-D visualization of (a) Carter Creek Bridge deck; (b) Van Buren Bridge (Gucunski et al. 2012).

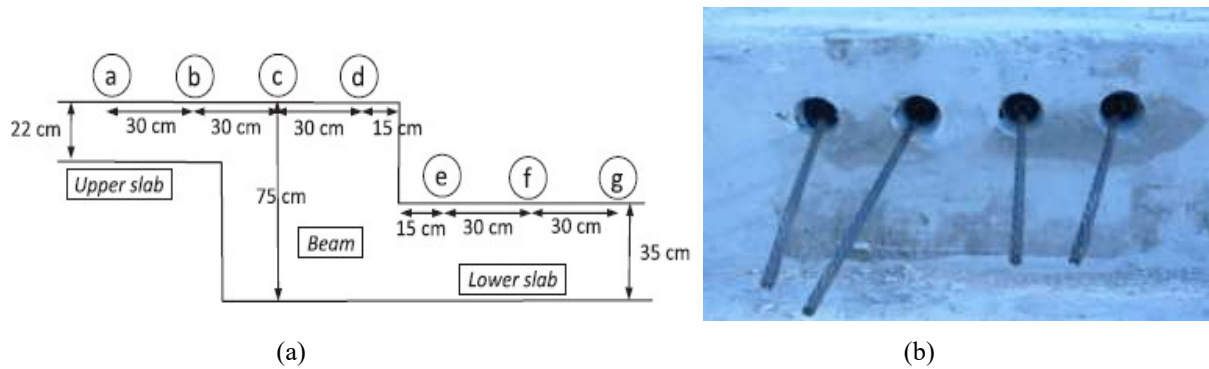
Figure 2.10: (a) IE test area; (b) crooked tendons in the PT system (Chaudhary 2013).

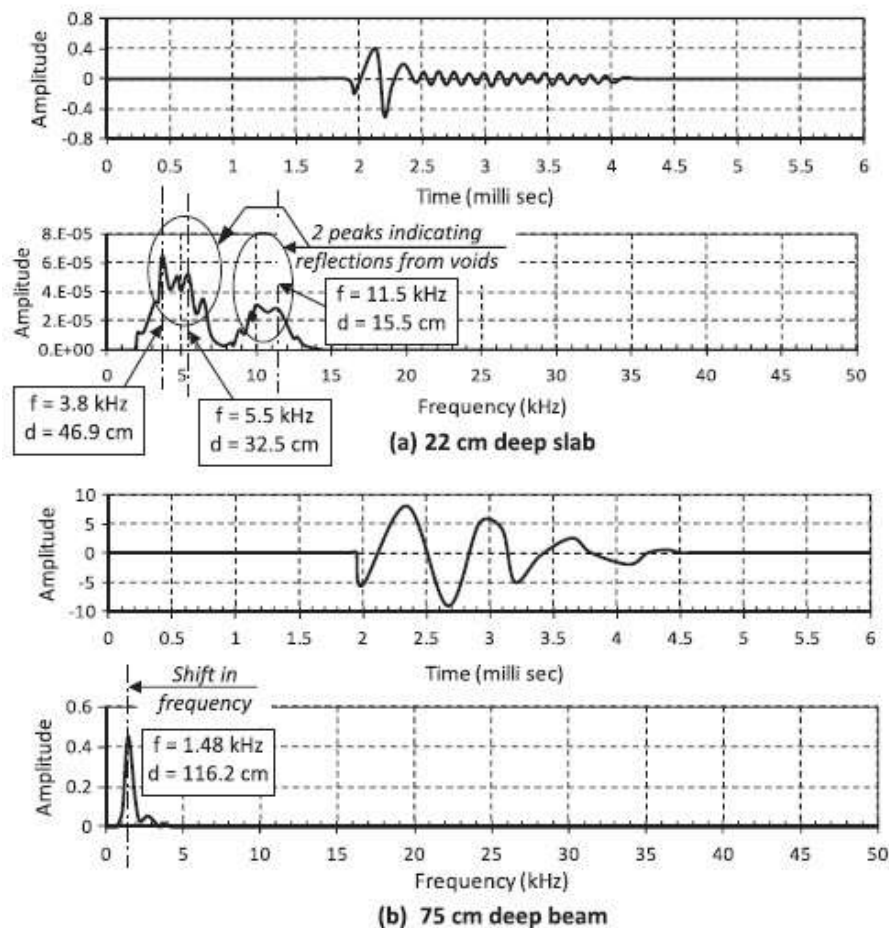
Figure 2.11: Time and frequency domain plots for upper slab and beam (Chaudhary 2013).

for beam, upper slab, and lower slab were 3582 m/s, 3720 m/s and 4116 m/s respectively, whereas the resonant frequencies ranges were found to be 2.14-2.32 kHz, 7.14-8.34 kHz, and 5.31-5.81 kHz respectively.

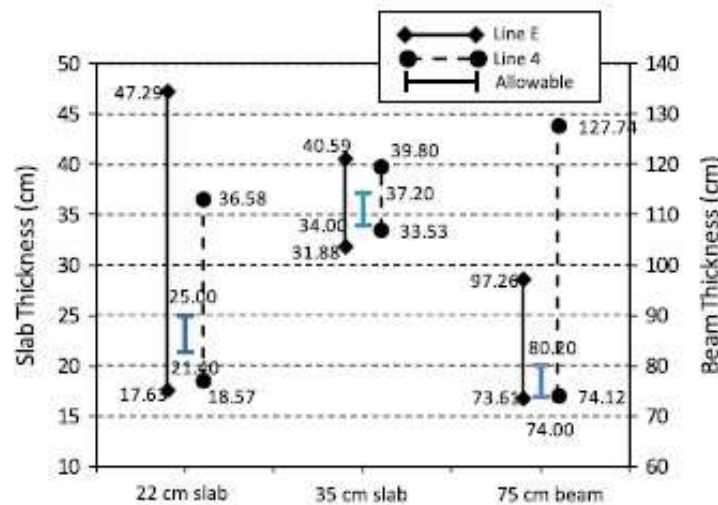
Figure 2.12: Comparison of thickness range measured by IE method and allowed by the code (Chaudhary 2013).

based on the thickness tolerance ranges in ACI 117-10. Figure 2.12 presents the comparison between measured and allowable thickness range for lines 4 and E separately. Based on the categories, 84% of the tested locations were classified as Good or Fair (without internal flaws), 10% were estimated Questionable (have possible voids) and 6% were considered Poor. The majority of the defected area was found in the upper slab and beam along line E as expected. These locations were further investigated by physical probing, which revealed that the accuracy of flaws prediction by the IE method was 60%. Experimental research concluded that the inaccuracy was caused by incorrect prediction of the geometric correction factor (K) in the equation to calculate thickness (Sangoju et al. 2009 and Schubert et al. 2004). It was found that K does not depend only on the member dimensions but is also influenced by the duration of the time-domain signals used in FFT and distance of point of measurement from the vertical boundaries. Adjusting the value of K in IE testing to 0.95 (suggested $\pm 5\%$) improved the accuracy to 81%.

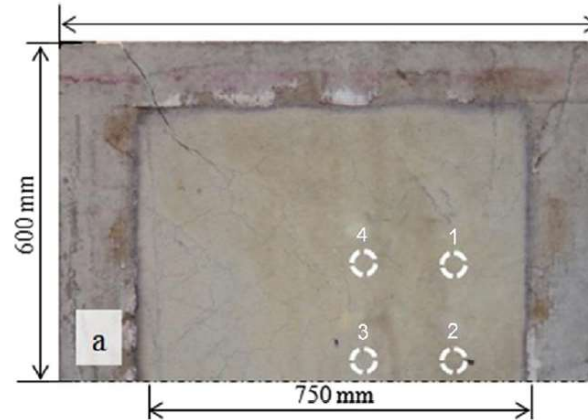
Figure 2.14: 4 sample points on concrete slab for IE test after exposing to heat (Krzemień and Hager 2015).

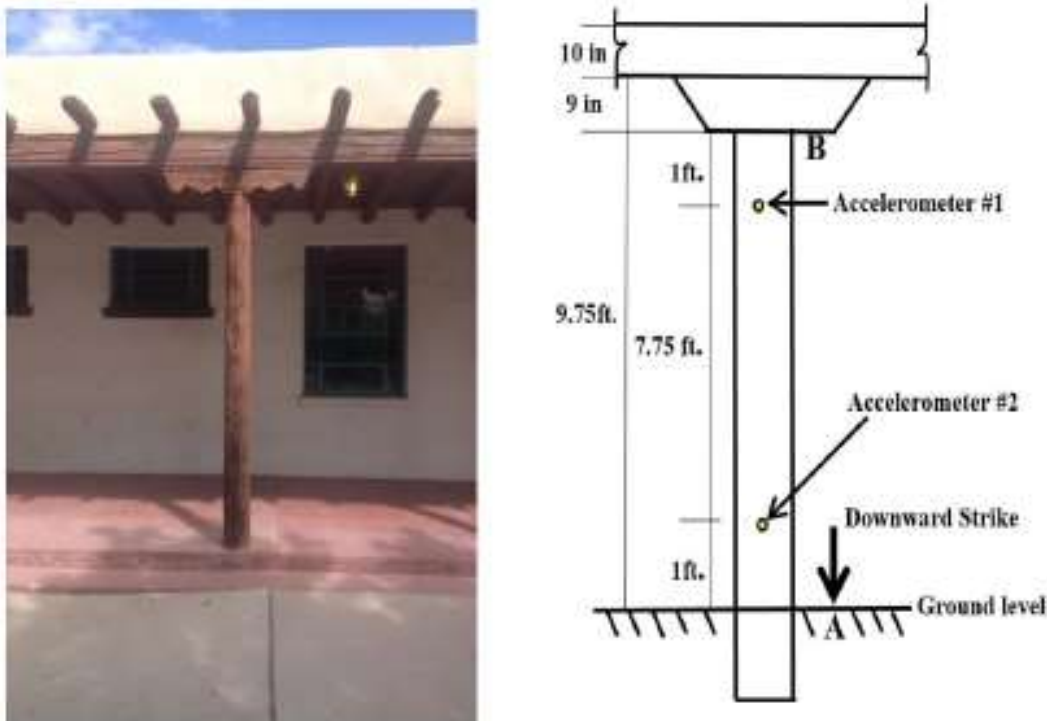
Figure 2.17: Wooden column test setup in Biology Annex Building (Jwary 2017).

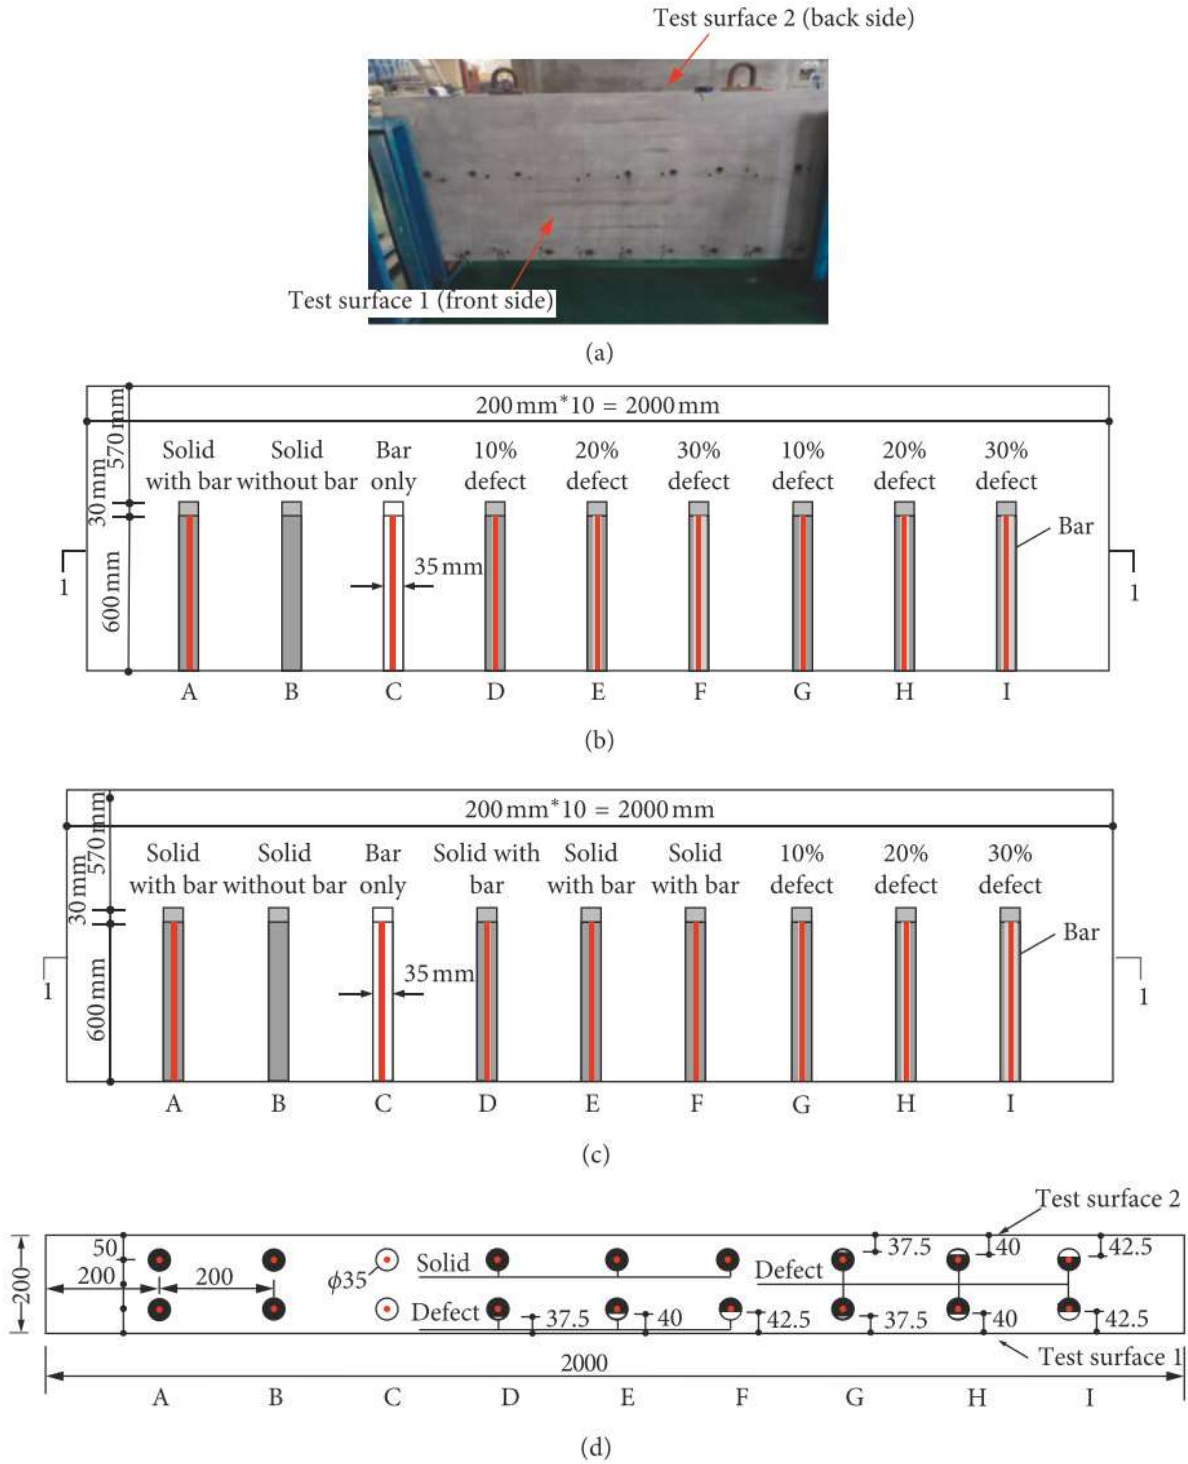
Figure 2.20: (a) Test specimen; (b, c) details of test surface 1 and 2; (d) section 1-1 (Liu et al. 2019).

IE tests were conducted on a precast shear wall ($2000 \times 1000 \times 200 \text{ mm}^3$) containing 18 grouting holes on two surfaces of the specimen. Each hole had a diameter of 35 mm, length of 630 mm, steel bar had diameter of 16 mm and anchorage length of 600 mm, and grouting outlet hole had a diameter of 30 mm. Each hole had different conditions on surface 1 and surface 2 as shown in Figure 2.20. The defects were formed using plastic foam and their holes had solid grout with steel bars. A test on solid concrete of the specimen was also conducted for reference. The frequency response of all the grouted holes were determined and compared using IE tests. The tests comprised of SPC-MATS equipment including a 6mm steel sphere impactor (contact time of approximately 25 μs) and a piezoelectric accelerometer (frequency up to 15 kHz). The impact was made at a distance of 20 mm to 30 mm for each test point. The specimens were tested on a total of 20 points (1-15 over the hole and 16-20 in the solid part), at intervals of 40 mm, along a line on both surfaces. For sound specimen, the frequency of 9.5 kHz was computed using equations 2.1, where, K , β , n , V_p and d were taken as 1.0, 0.96, 2.0, 3960 m/s, and 200 mm respectively.

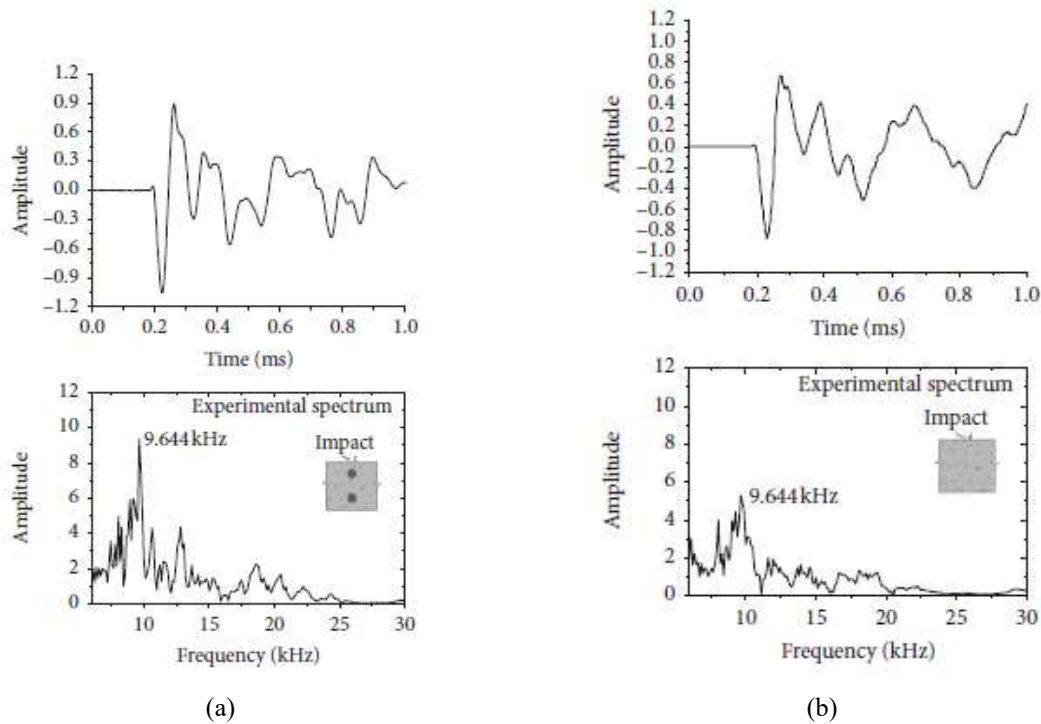
Figure 2.21: The waveform and frequency for (a) section with hole A; (b) solid concrete (Liu et al. 2019).

The results showed that the peak frequency of the solid wall (9.644 kHz), acquired using IE test, was consistent with that calculated using equation (9.5 kHz). Additionally, Figure 2.21 shows that the dominant frequency obtained for hole A was same as the solid concrete and hole B. This meant that fully grouted holes and holes with bar did not affect the frequency. For the defected holes, the peak frequency decreased for the ones with considerable defect. For hole G (10% void), the frequency was only slightly lower than that for solid concrete; but for holes with 20% and 30% void, it was as low as 9.277 kHz. The empty hole C showed the lowest peak frequency as the travel time of the wave increases significantly to go around the hole. Also, for the holes in two surfaces along C, the frequency spectrum showed only one peak amplitude instead of two because the frequency corresponding to the depth of nearest hole was beyond the instrument range. Moreover, for holes with small defect sizes, the frequencies obtained did not indicate actual condition. It was summarized that the dominant frequency decreased with the increase in void in the grout. The defect depth could not be calculated because the shift in the frequency were almost equal for both surfaces but the test was useful to indicate relative level of defects in grouted lap-splice connections.

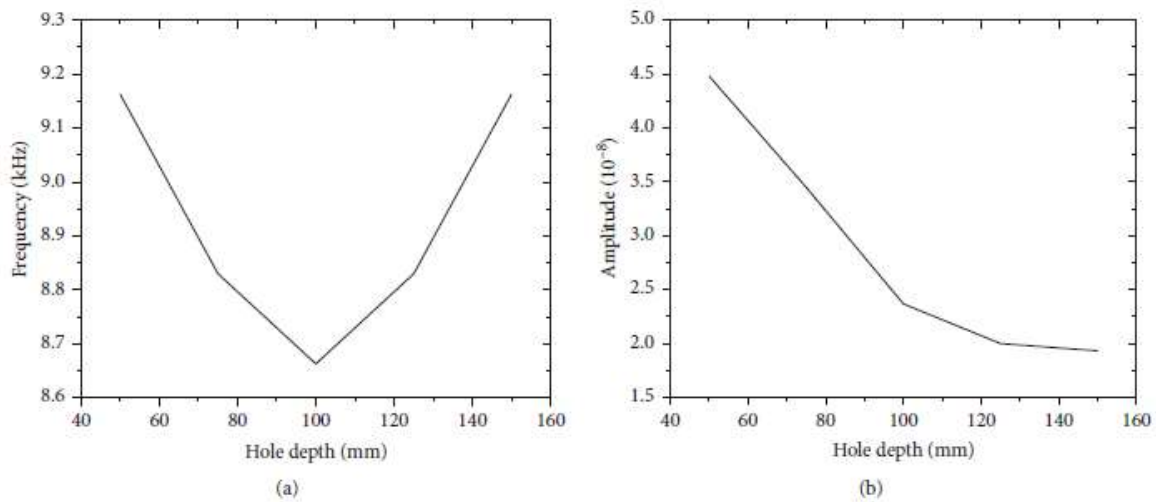
Figure 2.22: Relationships between (a) frequency and hole depth (b) amplitude and hole depth (Liu et al. 2019).

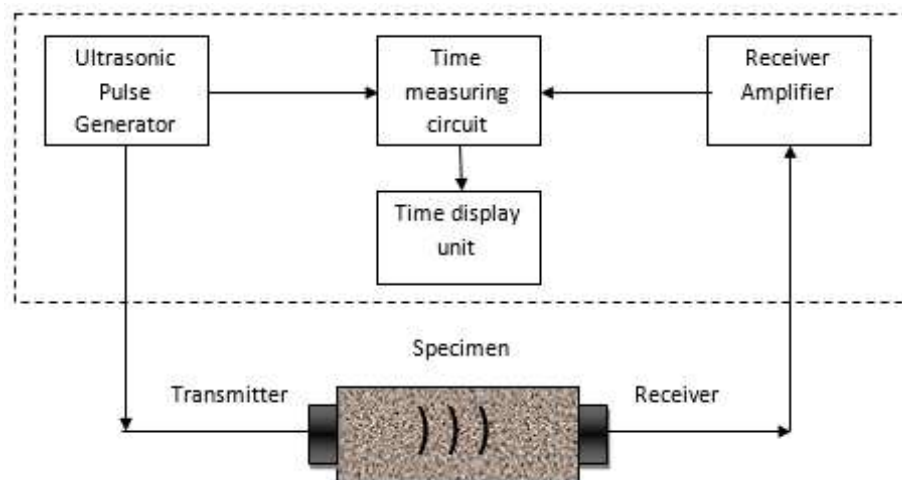
Figure 3.1: Schematic diagram of the ultrasonic wave velocity testing method (Bilgehan and Turgut 2010).

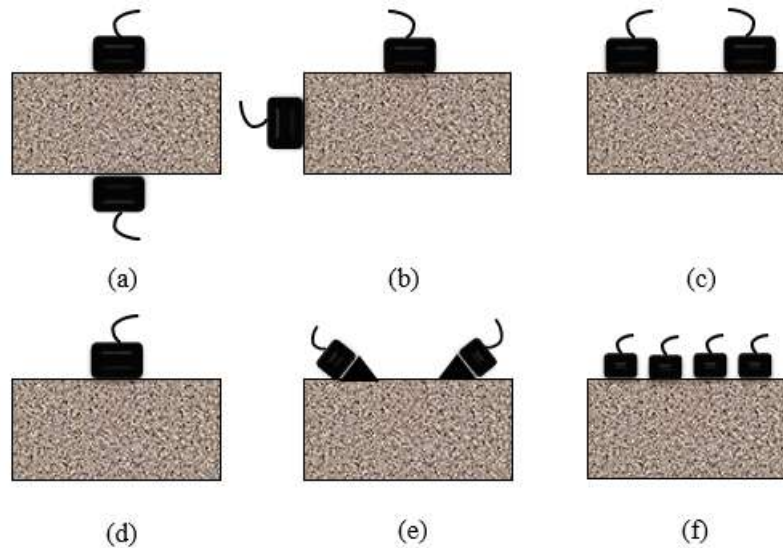
Figure 3.2: (a) Direct transmission, (b) Semi-direct transmission, (c) Indirect transmission, (d) Ultrasonic pulse-echo, (e) Angled beam assembly, (f) Ultrasonic array.

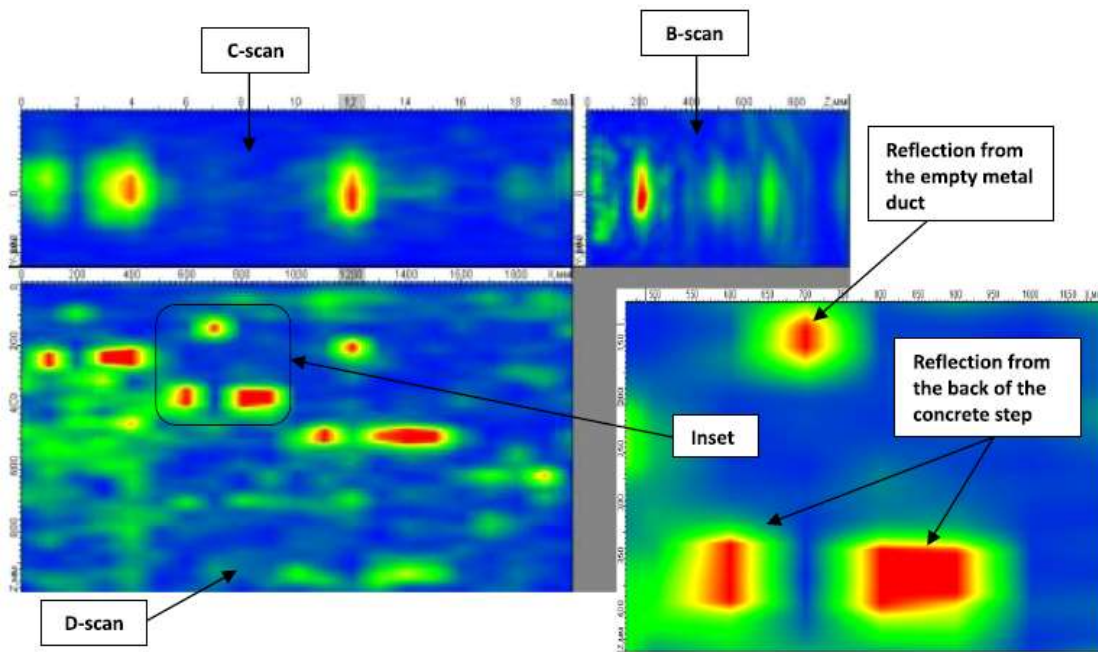
Figure 3.5: Mira results (B, C, and D scans) for the four-step concrete plate (Haza et al. 2013).

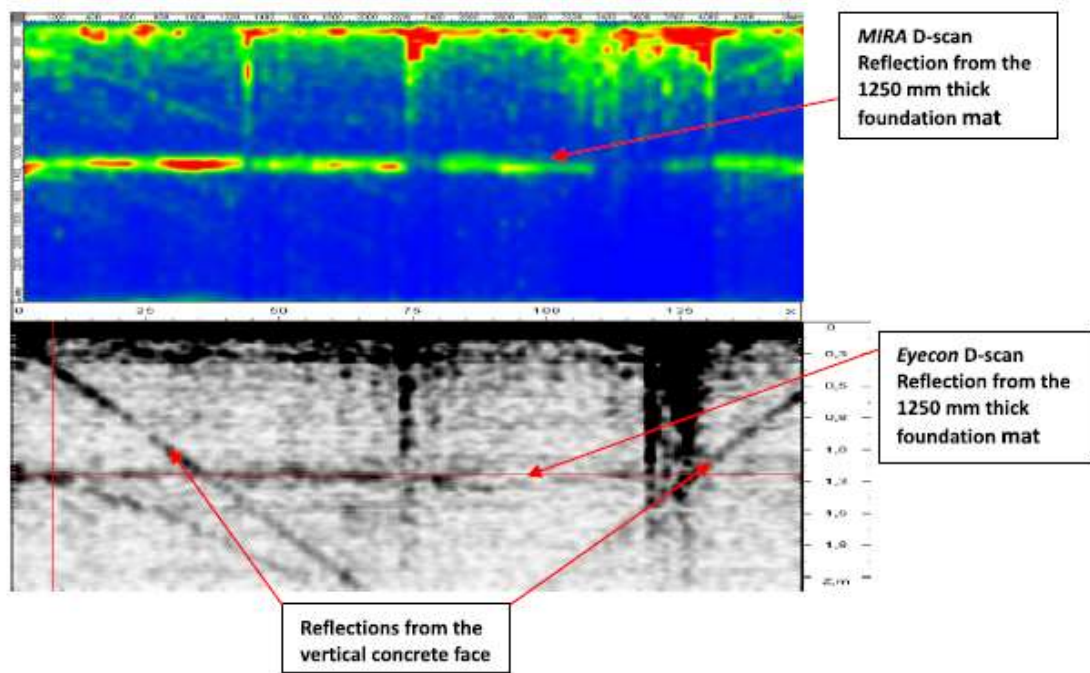
Figure 3.6: Mira (top) vs. Eyecon (bottom) results for 1.25 m deep concrete foundation mat (Haza et al. 2013).

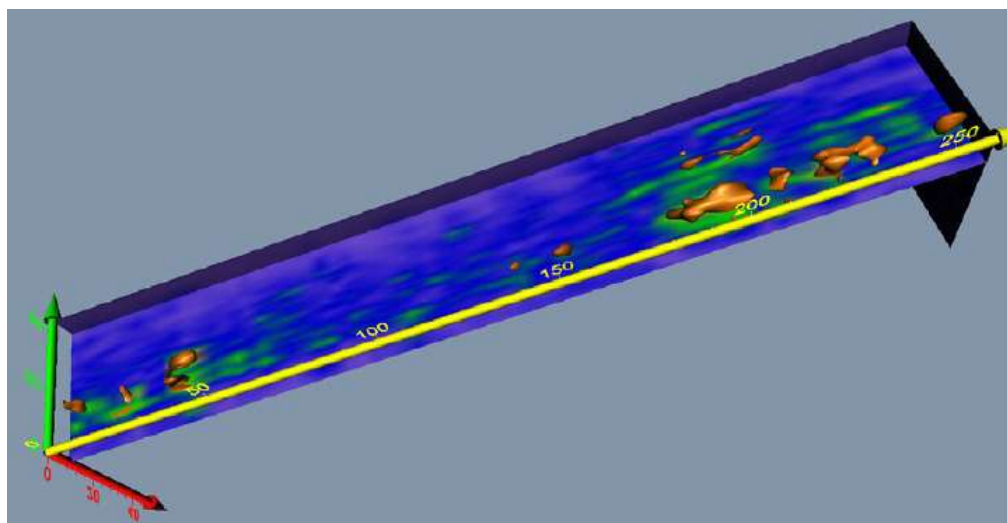
Figure 3.7: 3D isosurface view of Mira test results (Haza et al. 2013).

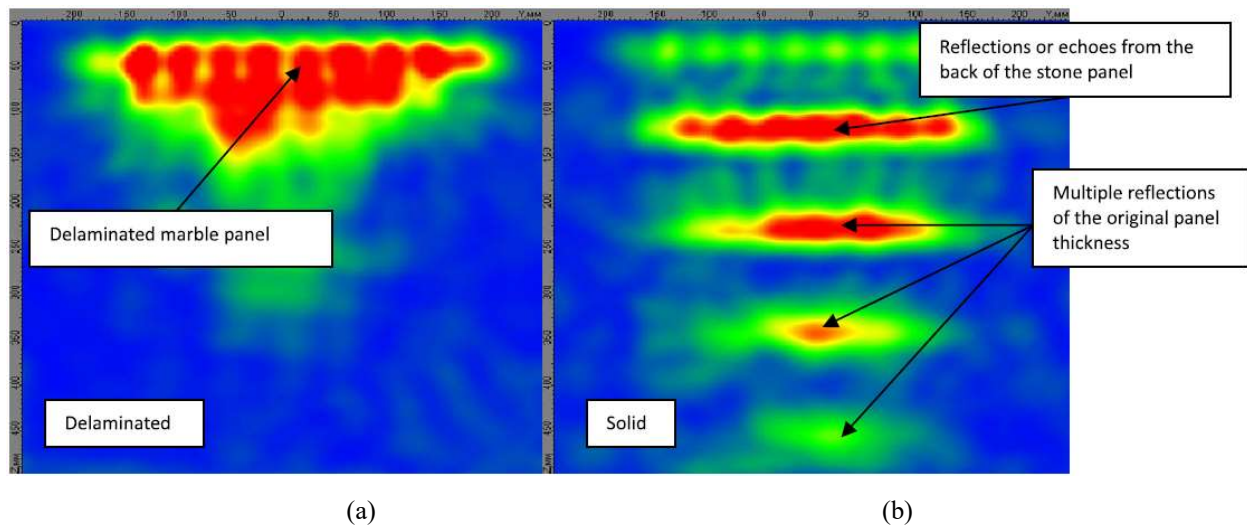
Figure 3.8: Mira results showing (a) delaminated area; (b) solid area (Haza et al. 2013).

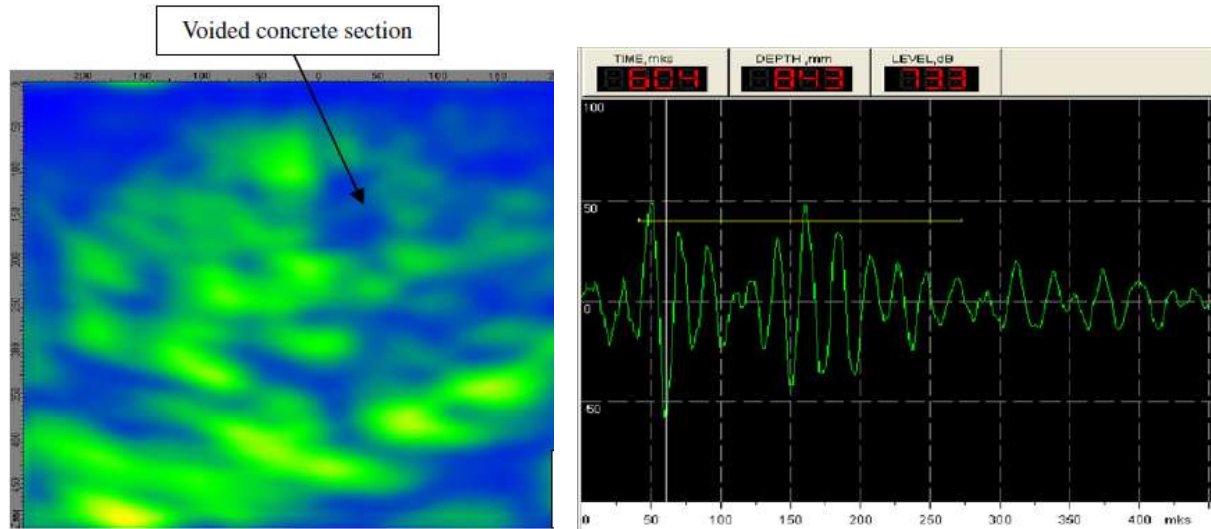
Figure 3.10: Mira delaminated area image (left); Eyecon A-scan showing delaminated depth (right) (Haza et al. 2013).

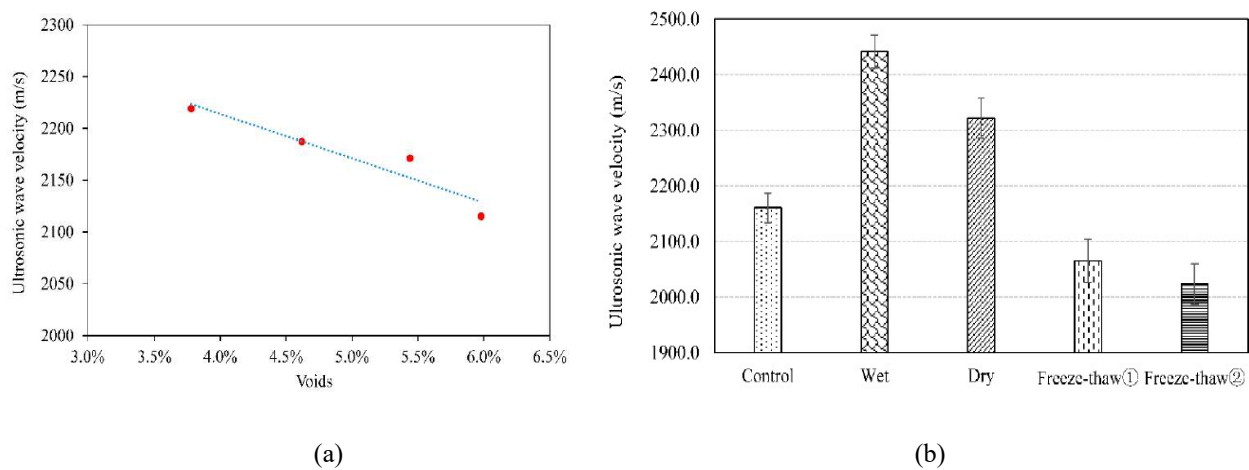
Figure 3.11: Comparison of ultrasonic velocities of Marshall specimens with different (a) voidage; (b) environmental conditions (Pan et al. 2019).

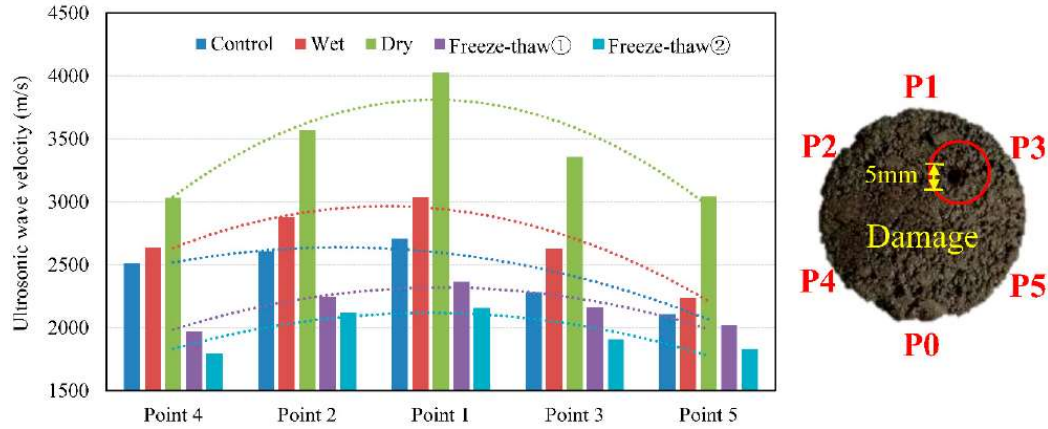
Figure 3.12: Ultrasonic velocity in a defected sample with different environmental conditions (Pan et al. 2019).

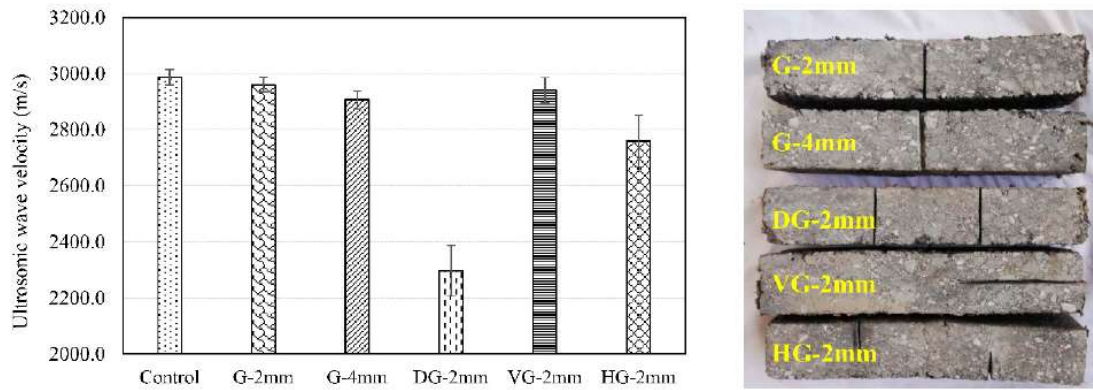
Figure 3.13: Ultrasonic velocity in five types of grooves in the samples (Pan et al. 2019).

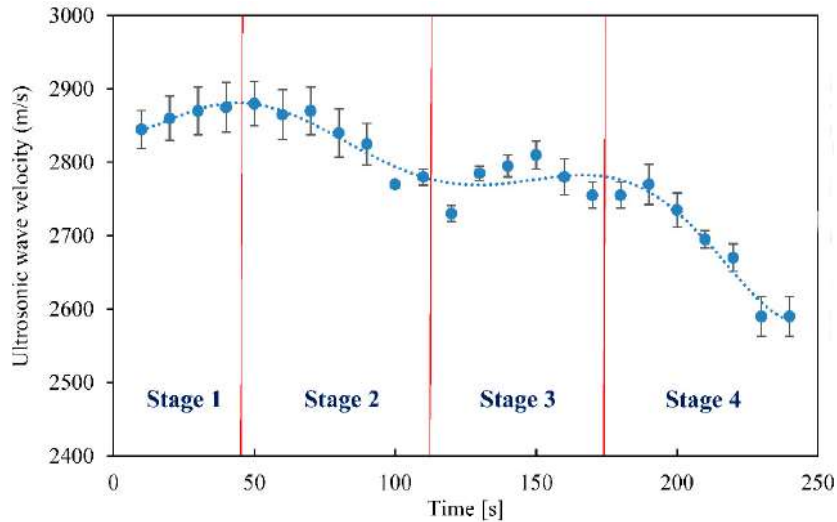
Figure 3.14: Ultrasonic velocity change trend during the entire process of damage (Pan et al. 2019).

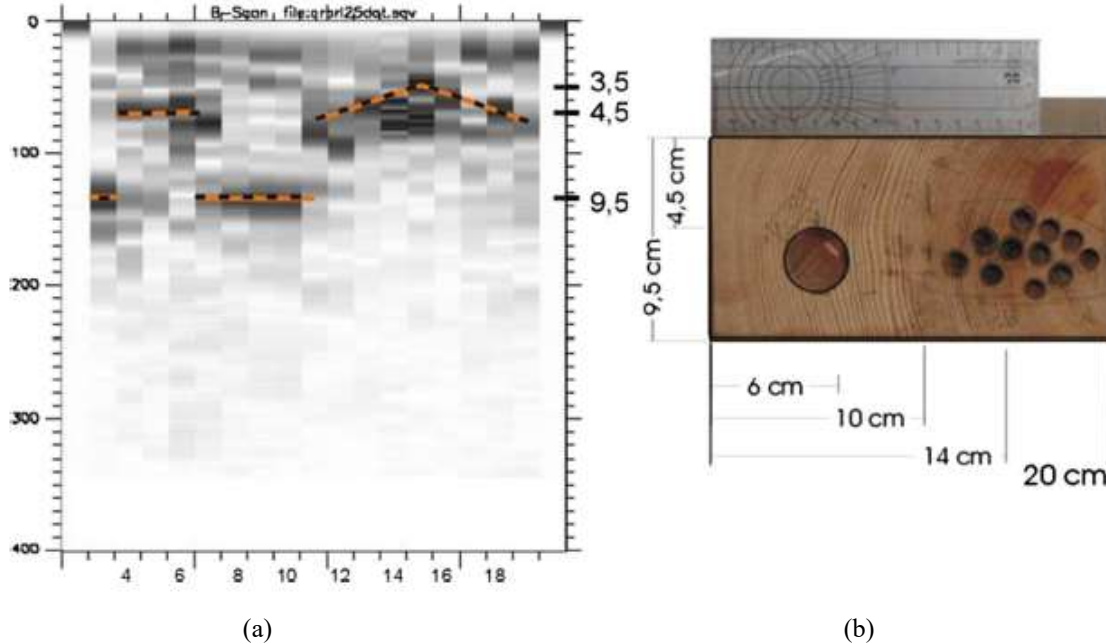
Figure 3.18: (a) B-scan of the sample obtained from the ultrasonic echo method (units in mm); (b) Timber sample with defects (Dackermann et al. 2014).

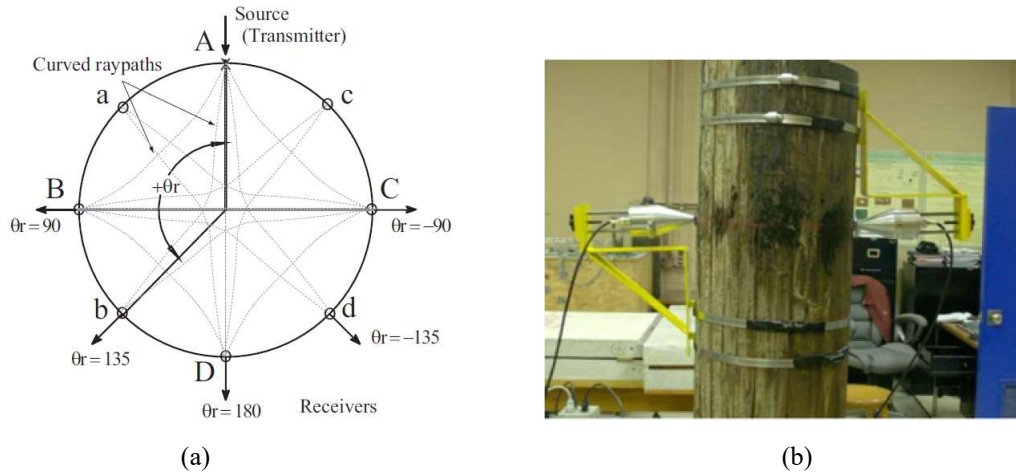
Figure 3.19: (a) Ultrasonic transducer setup with raypaths; (b) test setup in aged specimen (Tallavo et al. 2012).

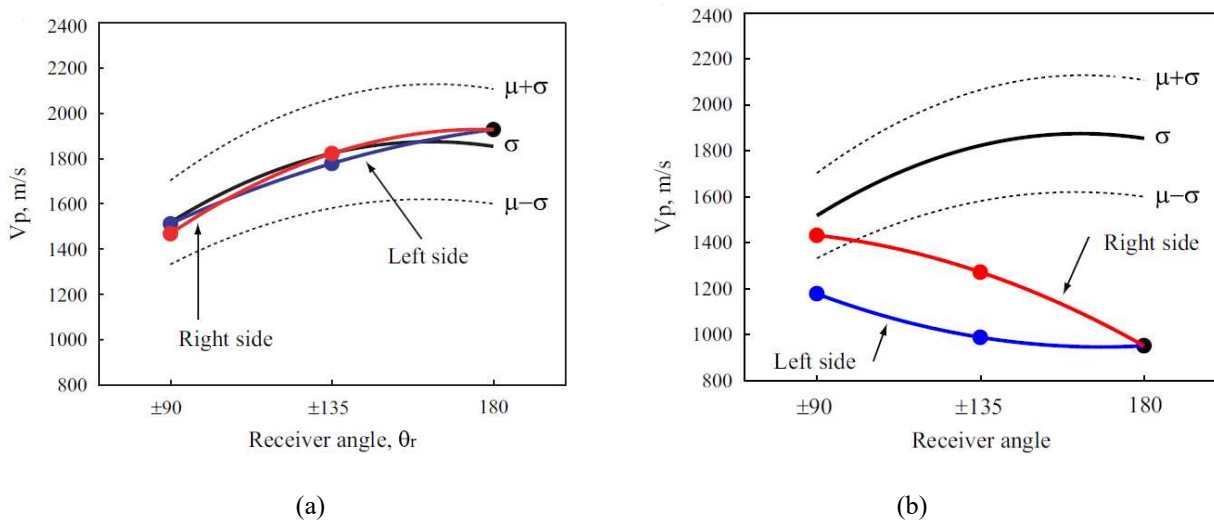
Figure 3.20: (a) Measured wave velocity for different receiver positions in new pole; (b) aged pole (Tallavo et al. 2012).

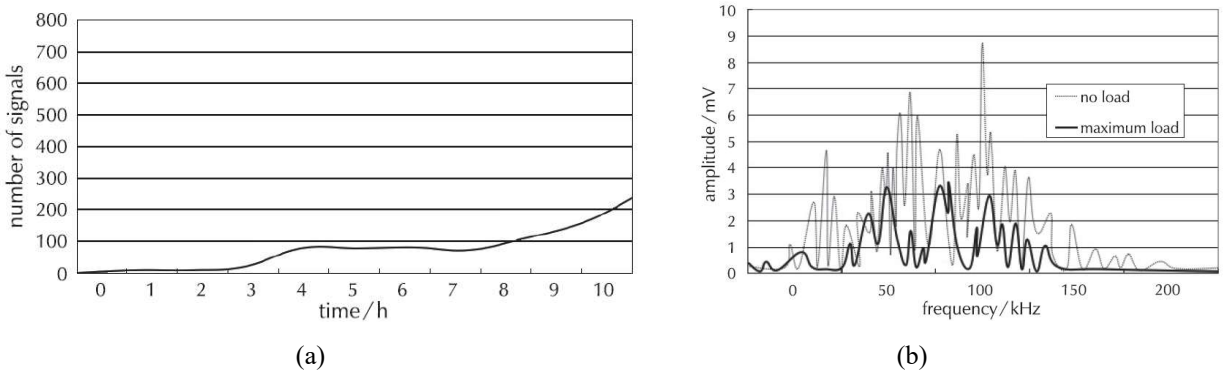
Figure 3.23: (a) Time of corrosion vs. the number of ultrasonic signals; (b) Received ultrasonic signals under different loadings (Peng 2017).

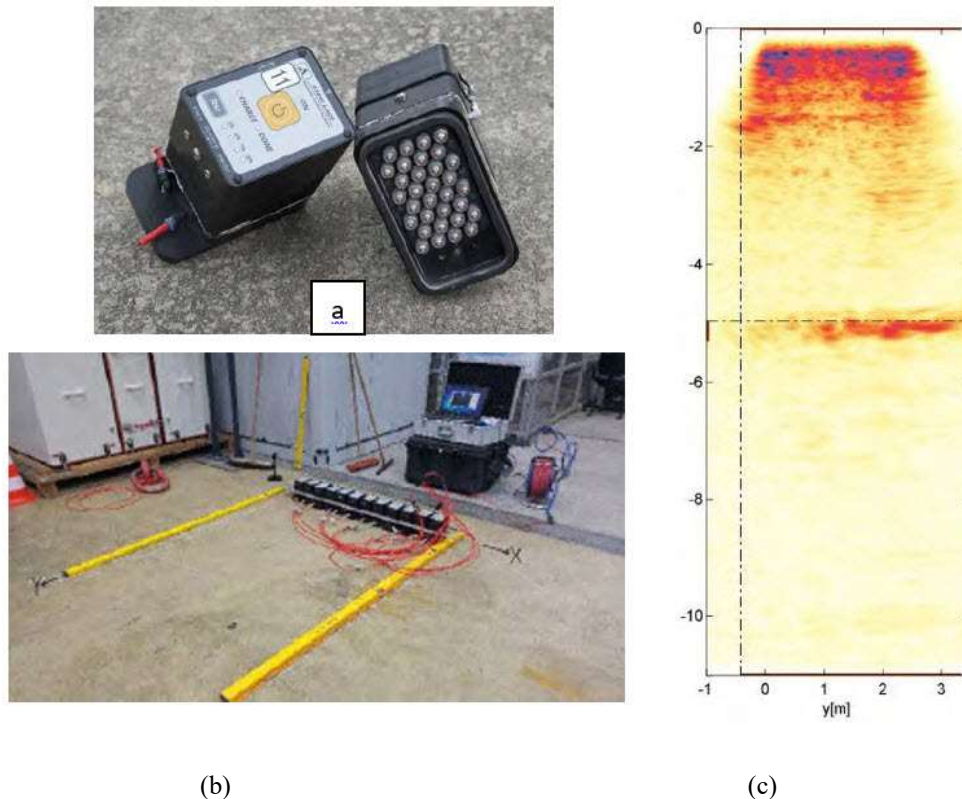
Figure 3.25: (a) The LAUS unit; (b) Foundation slab under test with LAUS data acquisition; (c) SAFT-reconstructed B-scan of the slab (Niederleithinger and Wiggenghauser 2018).

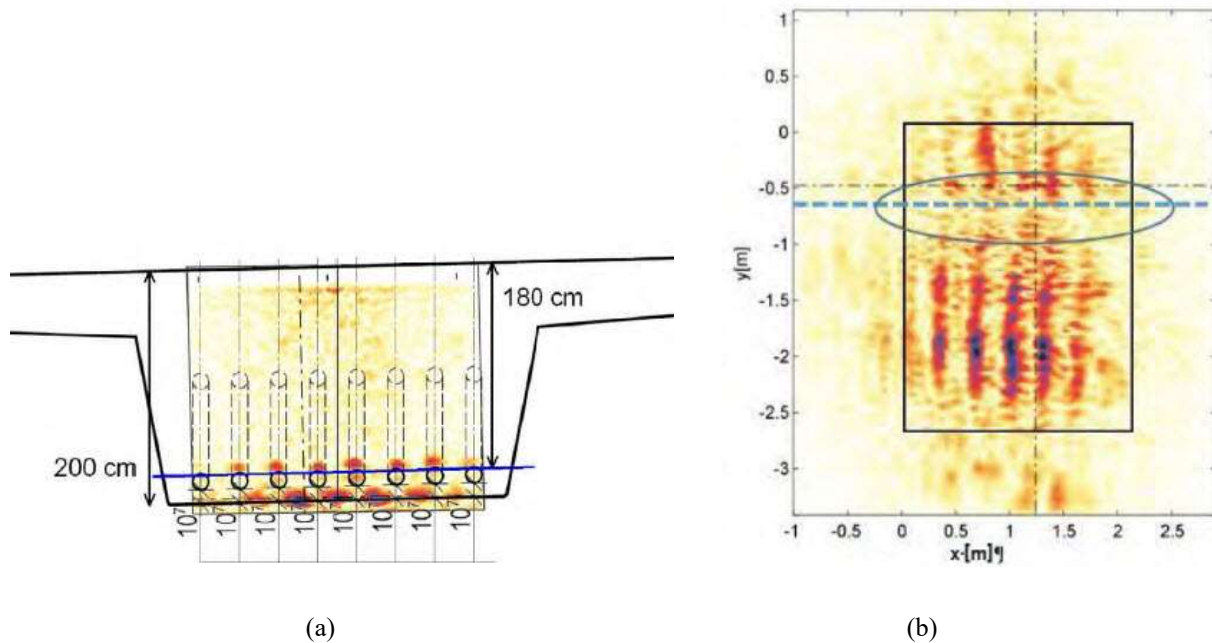
Figure 3.26: (a) SAFT-reconstructed B-scan of the girder at 1.8 m depth; (b) C-scan of the girder at 1.8 m depth: rectangle - measurement area, hatched line - the level of concrete at the start of rainstorm and ellipse - anomalous area (Niederleithinger and Wiggenhauser 2018).

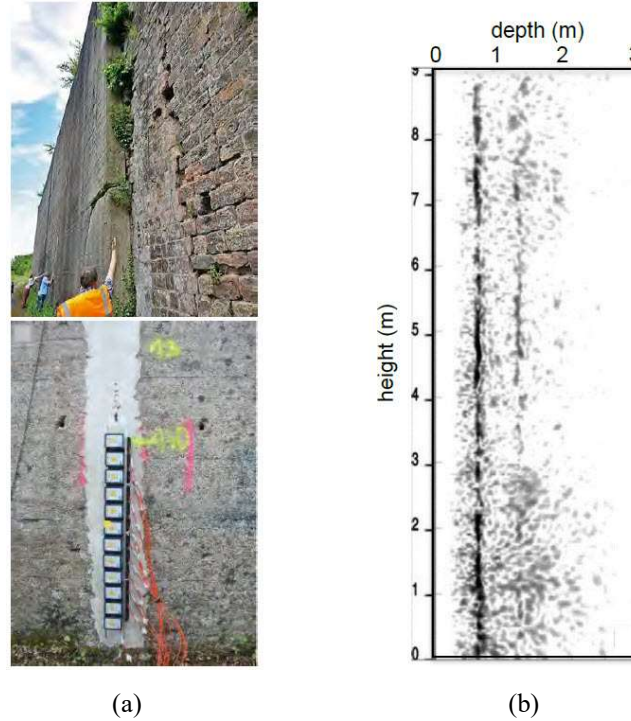
Figure 3.27: (a) The LAUS system data acquisition in the retaining wall in former coal mine plant; (b) Soft-reconstructed B-scan of the retaining wall (Niederleithinger and Wiggenhauser 2018).
